K42 Asset Condition Project

Franklin County Line Upgrade

St. Albans Select Board

June 6, 2022

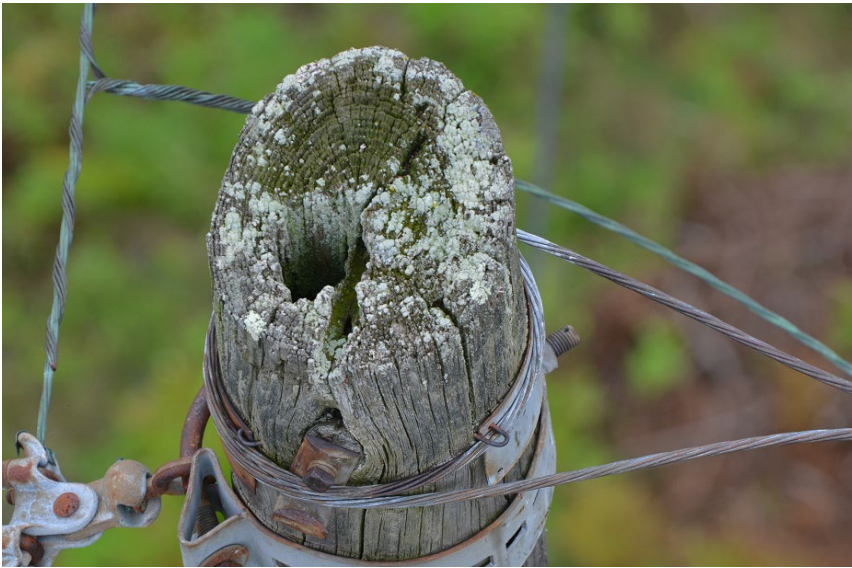
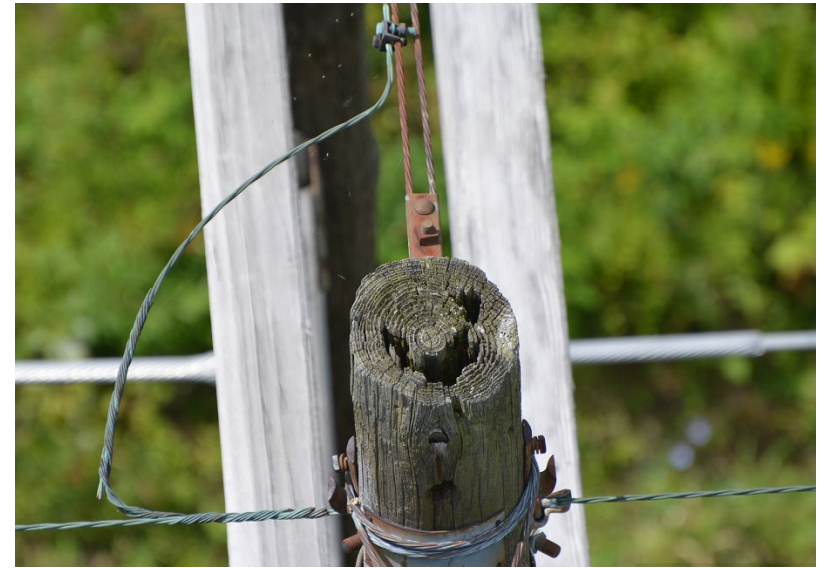
Examples of rotted pole tops

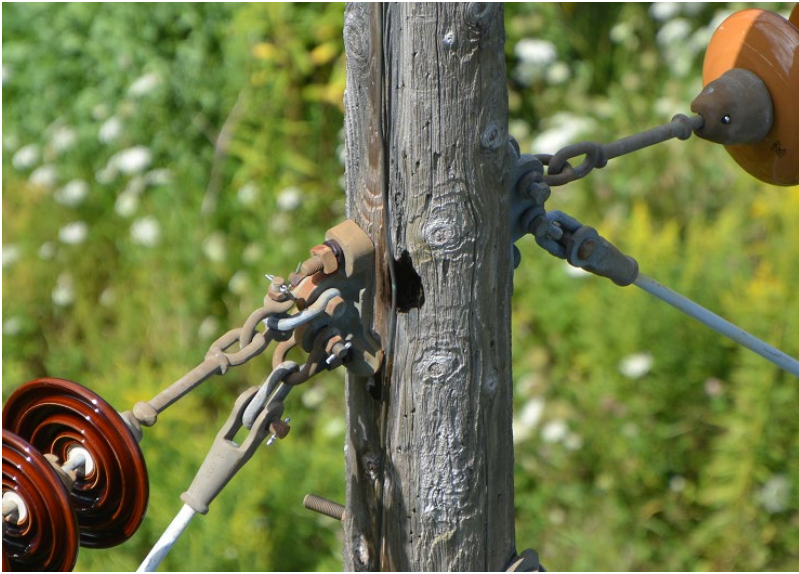
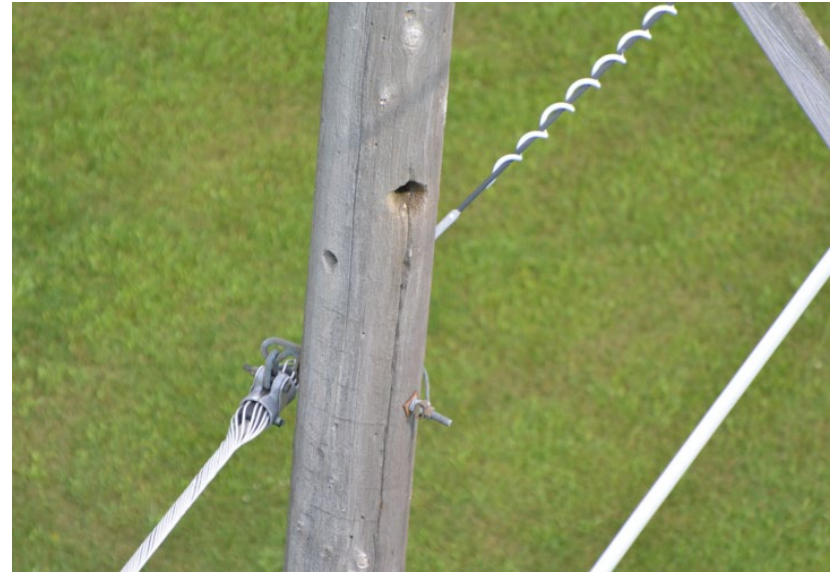
Examples of woodpecker damage

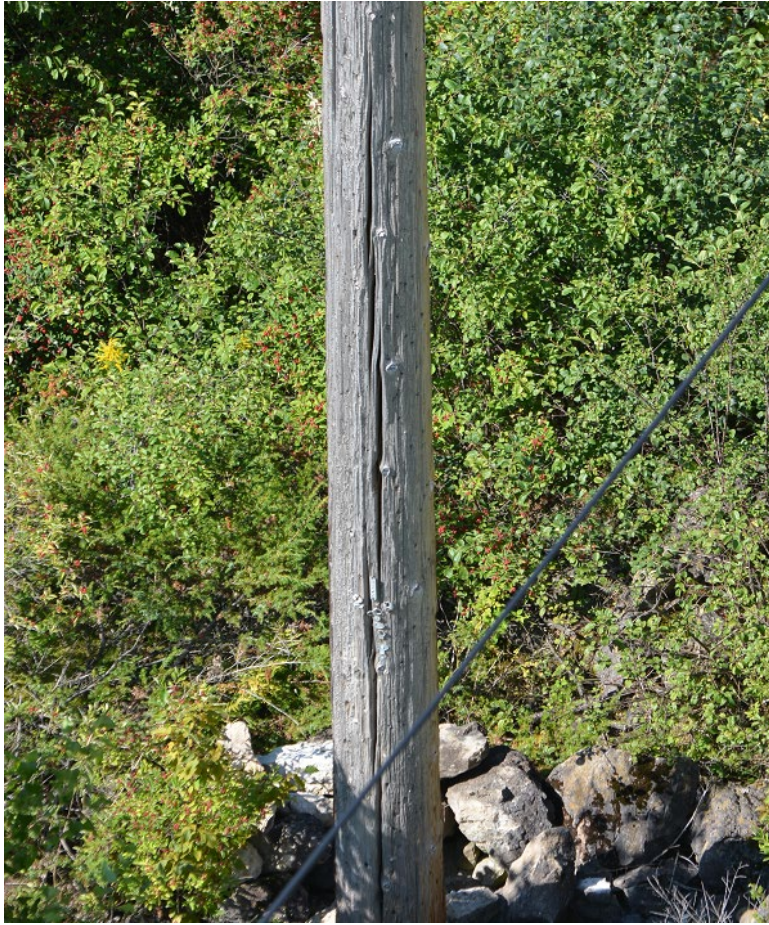
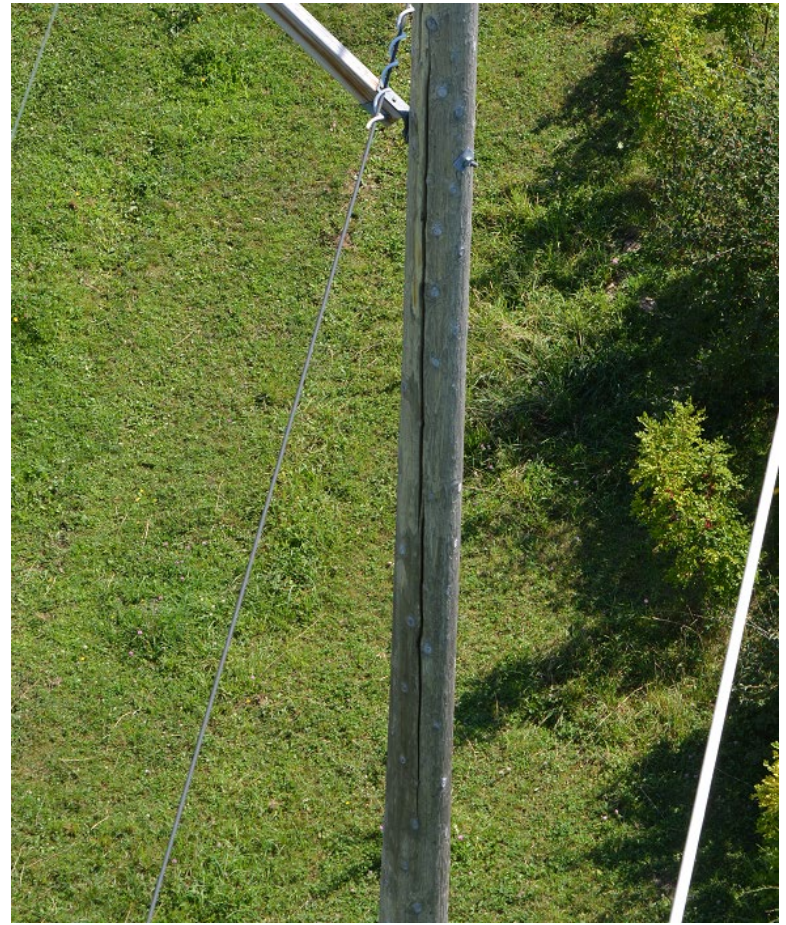
Examples of poles splitting

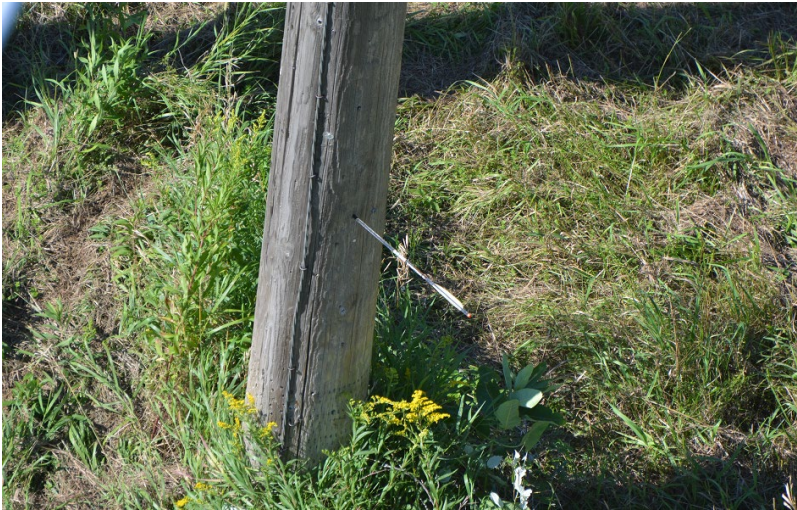
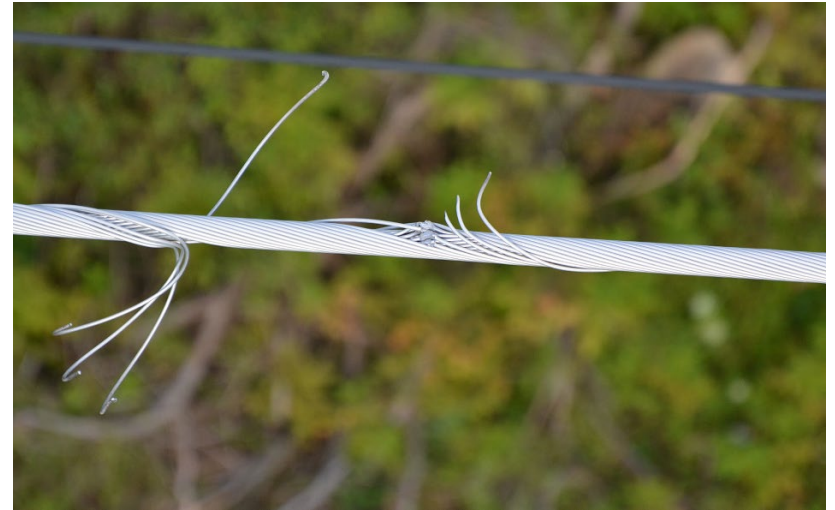
Examples of target practice damage
