**PHASE I ARCHAEOLOGICAL IDENTIFICATION SURVEY
VELCO FRANKLIN COUNTY LINE UPGRADE PROJECT**

Towns of Highgate, Georgia, Saint Albans, and Swanton
Franklin County, Vermont

October 17, 2023

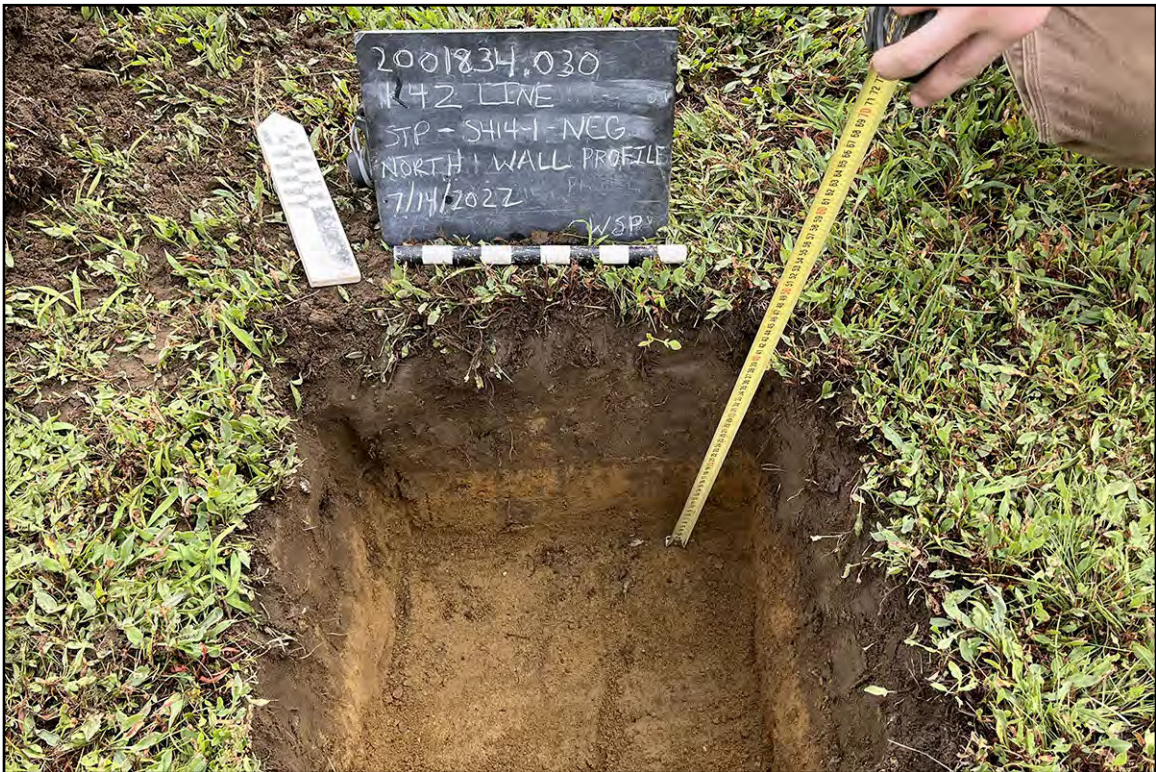
PLATE 15: Shovel Test S414-1, North Wall Profile

During 2023 seven shovel tests were excavated at Structure 414. These consisted of four placed at 10-meter intervals and three placed at 5-meter intervals when one initial shovel test was found to be positive for post-Contact artifacts (see Figure 9, Sheet 4; see Plates 16 and 17).

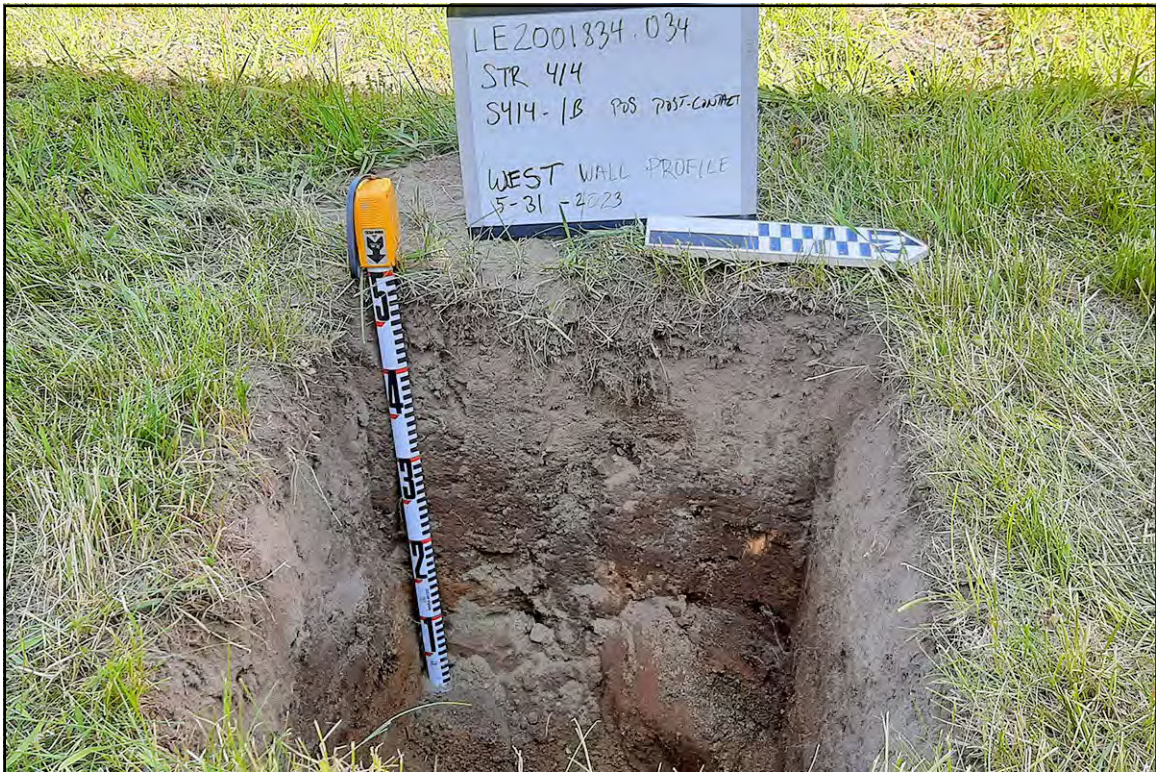
PLATE 17: Shovel Test S414-1B West Wall Profile

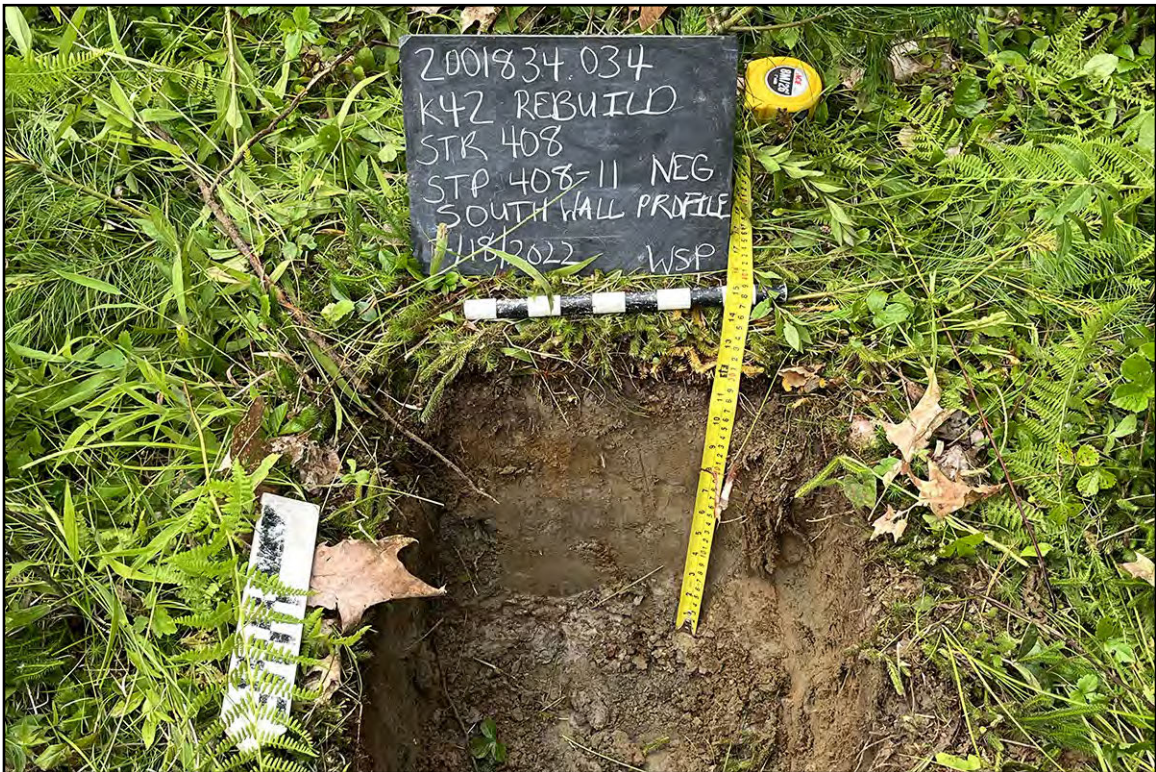
PLATE 24: Shovel Test S408-11, South Wall Profile

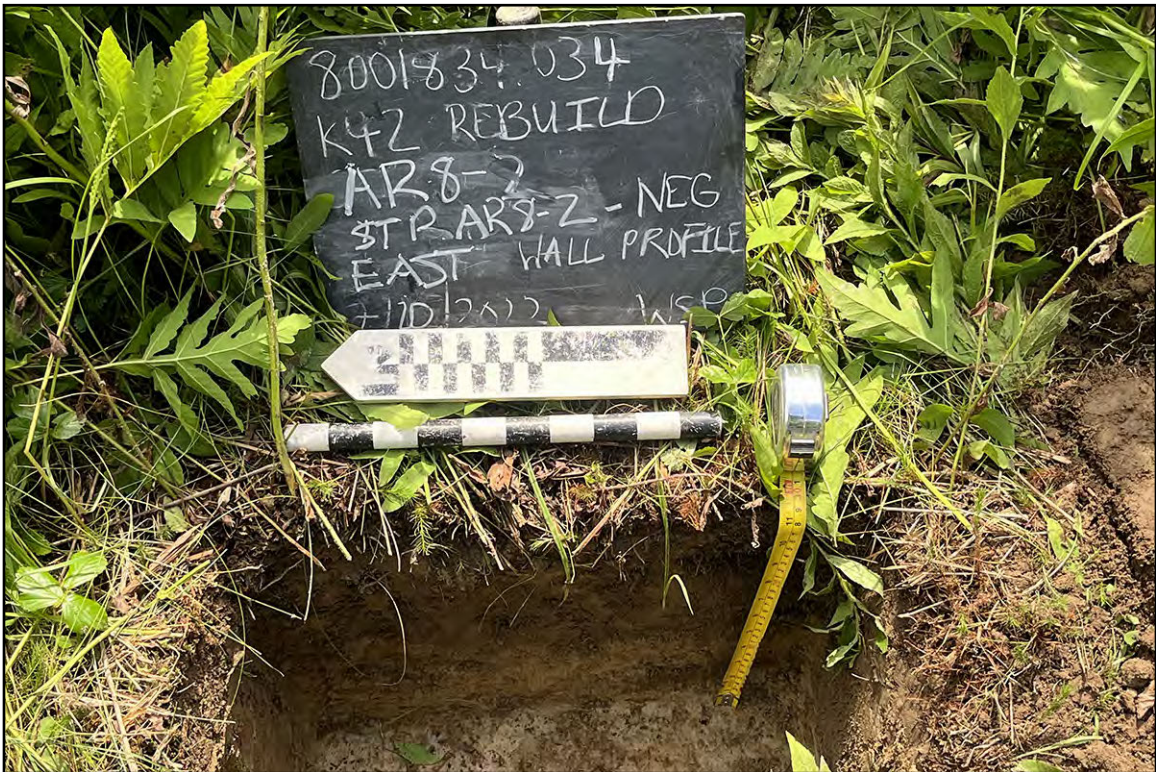
PLATE 30: Shovel Test AR8-2, East Wall Profile

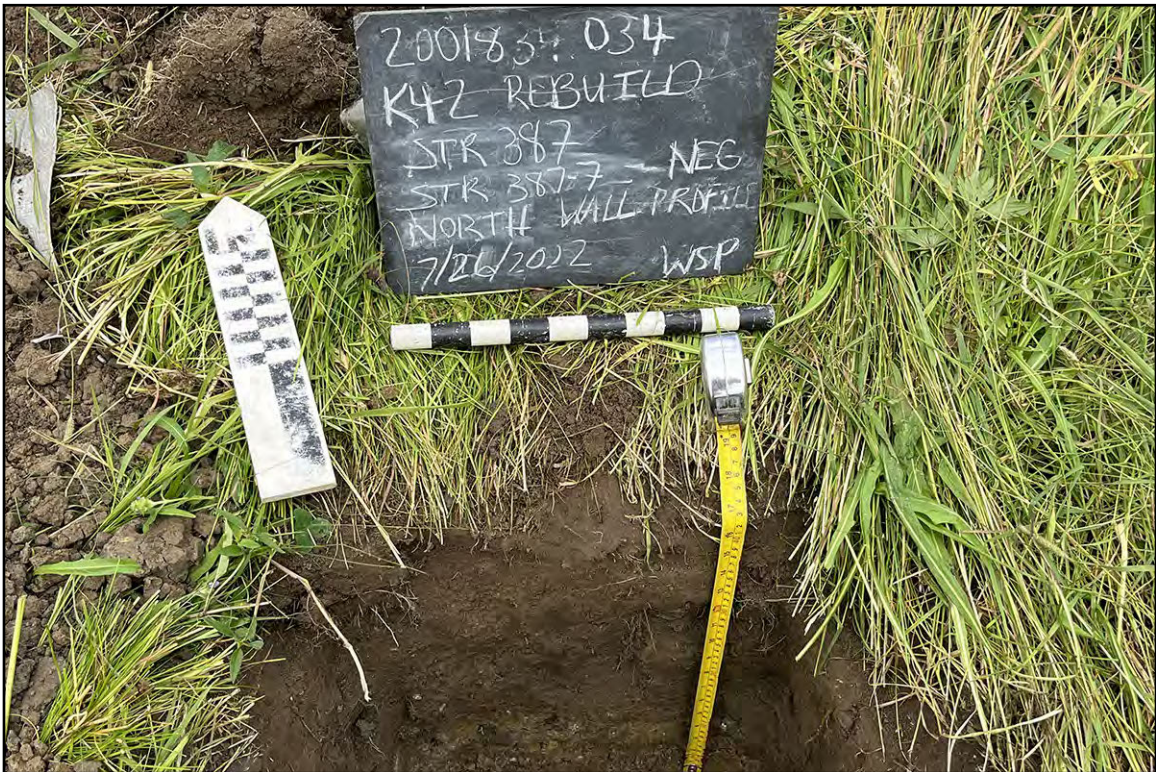
PLATE 40: Shovel Test S387-7, North Wall Profile

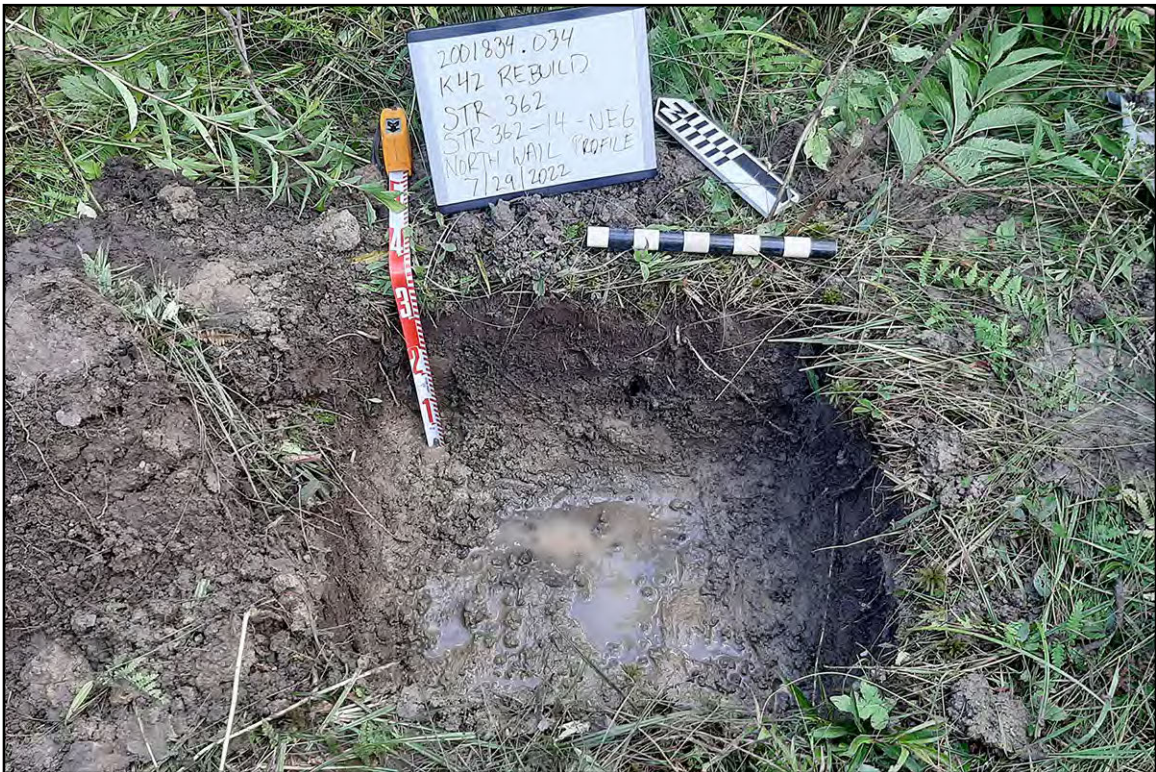
PLATE 51: Shovel Test 362-14, North Wall Profile

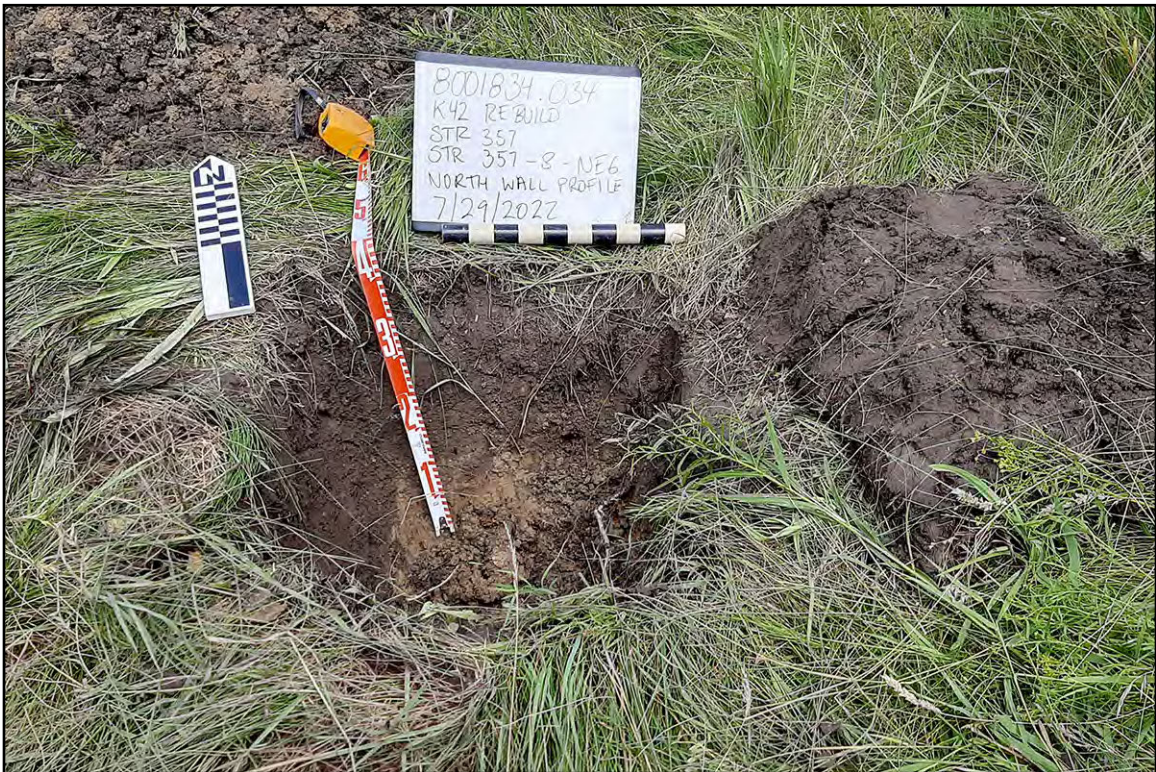
PLATE 55: Shovel Test 357-8, North Wall Profile

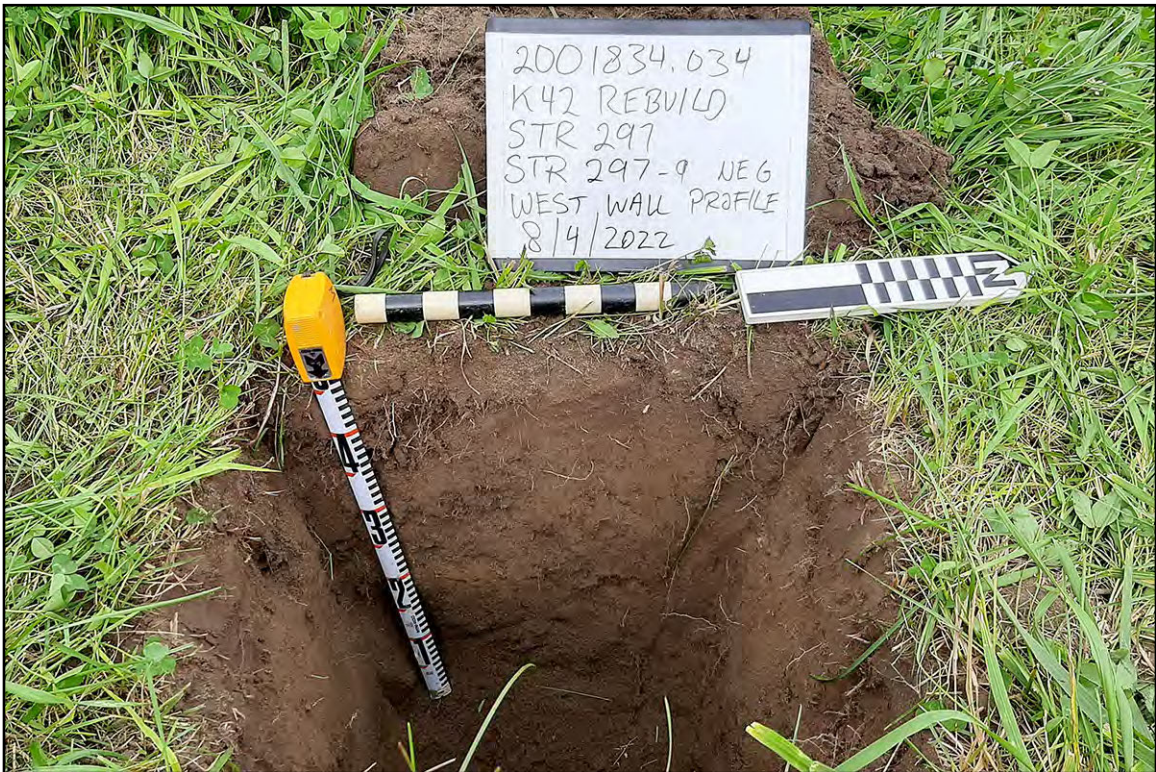
PLATE 91: Shovel Test 297-9, West Wall Profile

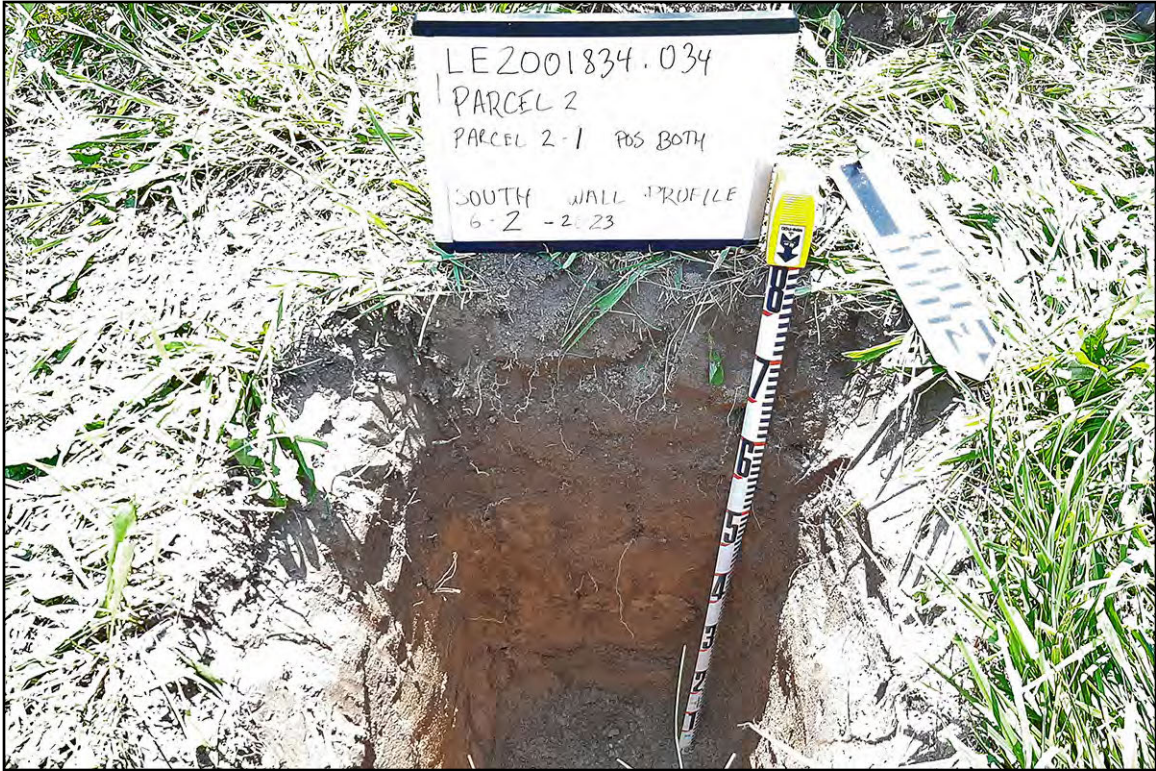
PLATE 94: Shovel Test P2-1 South Wall Profile

All artifacts were found in Stratum A, between 0 and 41 centimeters (0 and 16.14 inches) bgs, except two machine-cut nails, which were found in Stratum B, between 7 and 37 centimeters (2.76 and 14.57 inches) bgs). Considering the depths at which the artifacts (along with modern materials such as window glass, wire nails, and plastic) were recovered, it appears that there is no consistent vertical distribution of materials and that the deposits are not intact. The assemblage was sparsely distributed and provides limited information. In WSP's opinion Site TS 1834-04 is not eligible for the NRHP under Criterion D and no additional testing or avoidance is needed.

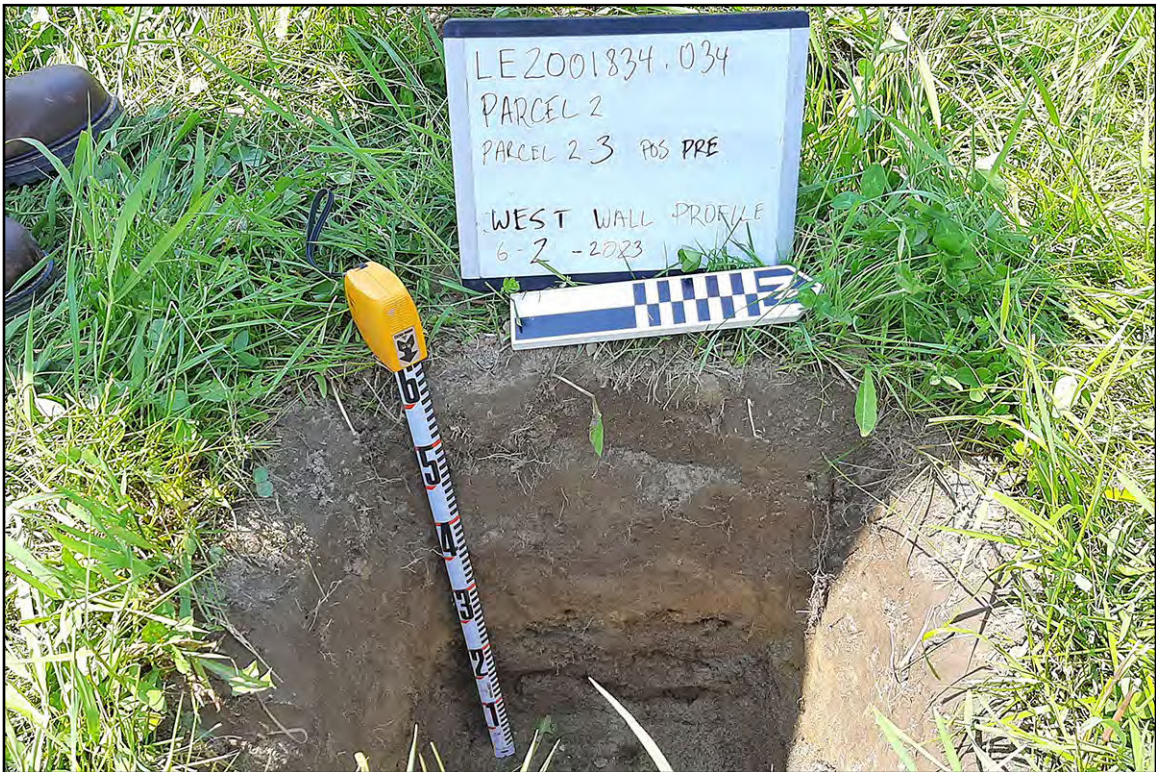
PLATE 95: Shovel Test P2-3 West Wall Profile

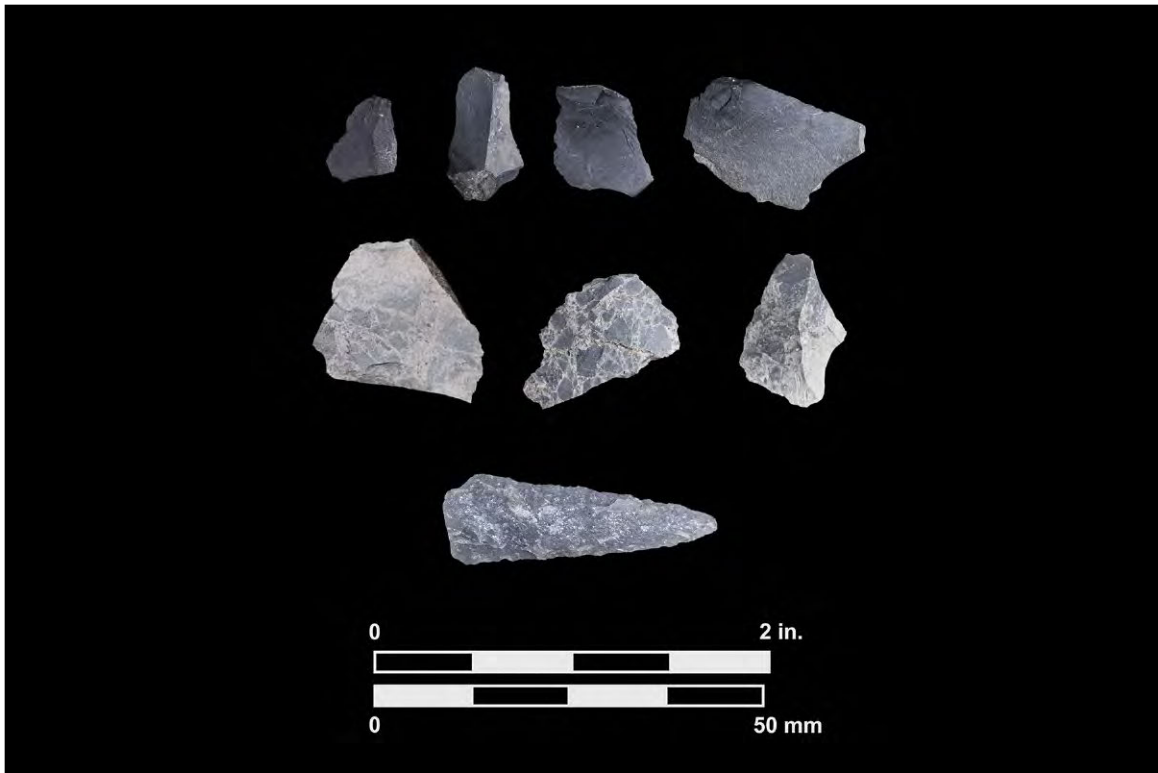
PLATE 130: Argillite or Chert Flakes and Blue-Gray Quartzite Drill Fragment from Site VT-FR-0458

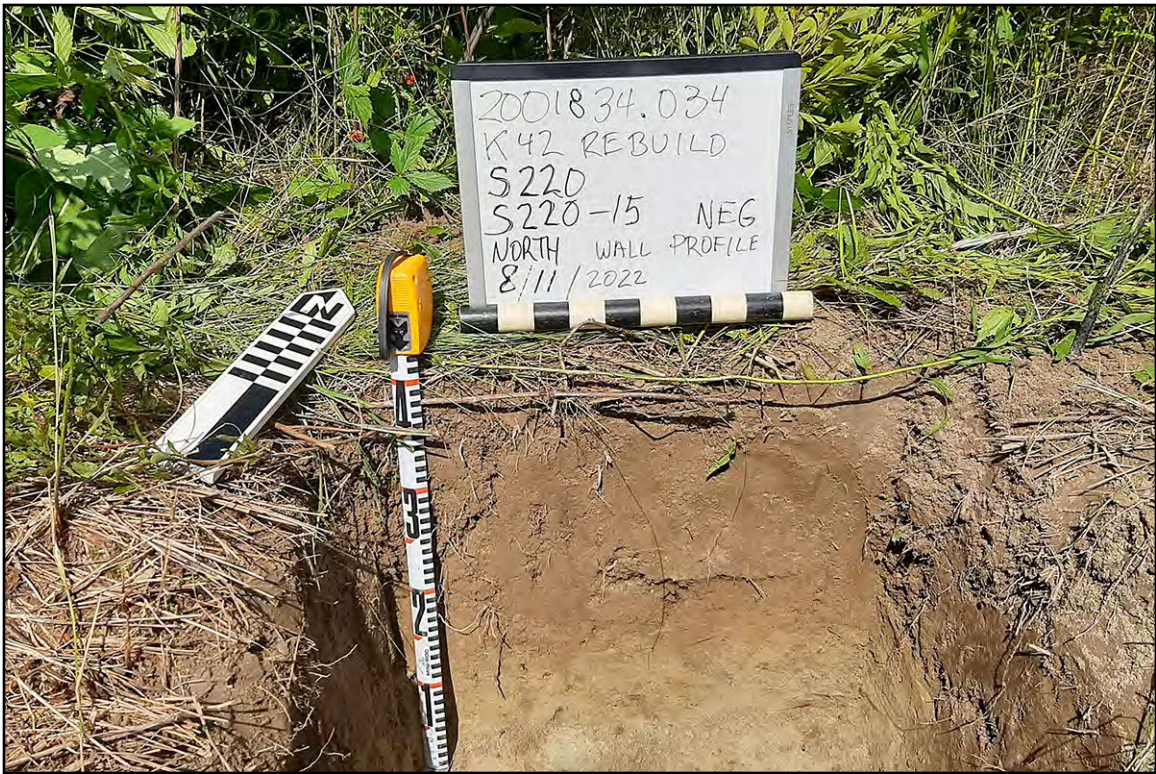
PLATE 153: Shovel Test 220-15, North Wall Profile

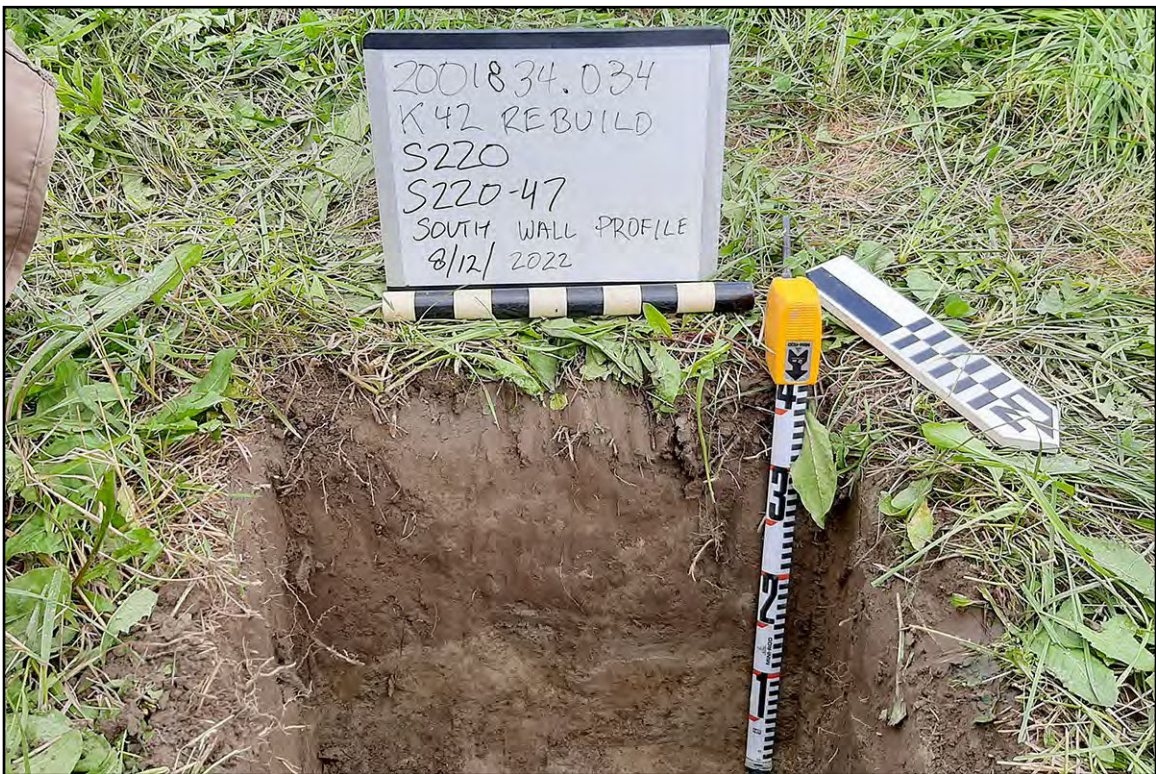
PLATE 154: Shovel Test 220-47, Southern Wall Profile
